Manhole Inspection Summary

Manhole # S17CC1008MH

Insp Date: **2/20/07 11:05 AM**

Location Address: **2261 PARK HILL AVE**

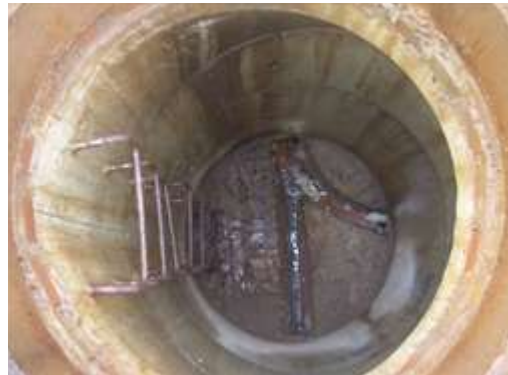
Top View

Infiltration: ☐ None ☒ **Joint** ☐ Cracks ☐ Mortar ☐ Roots ☐ Wall

Infiltration: ☐ None ☐ Joint ☐ Cracks ☐ Mortar ☐ Roots ☒ **Wall**

Bench ☒ Exists Material: **Brick** ☐ Parged ☒ **Debris** (not Condition related)

Steps Count: **8** Missing: **0** ☒ **Corroded**

Barrel infiltration. Corroded steps. Bench debris.

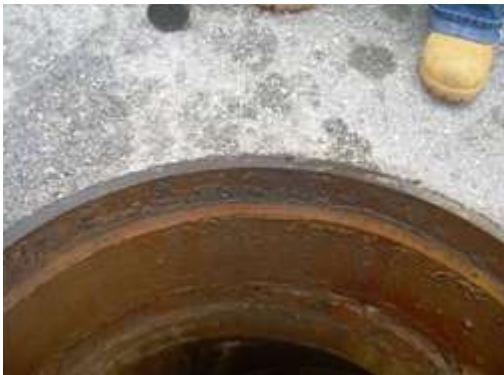
Defect

Frame Offset: **0** (in.) Condition: ☐ Sound ☐ Cracked ☒ **Leaks**

Frame leaks. Adjustment infiltration.

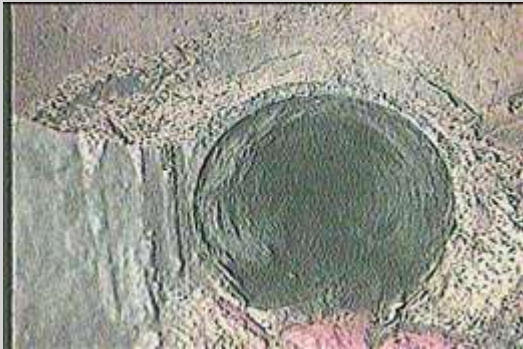
8 in. Circular Gravity Sewer Pipe Out @ 12 O'Clock

Pipe Material: **DIP/CI** ☐ Pipe Lined

Invert Depth: **9.78** (ft.) Flow Characteristics: **Slow**

Infiltration: **None** Pipe Seal Cond: **Unknown**

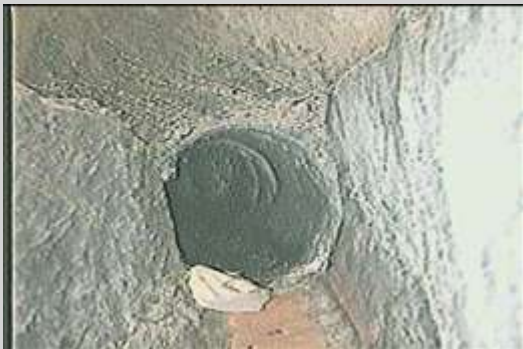
6 in. Circular Gravity Sewer Pipe In @ 3 O'Clock

Pipe Material: **Clay** ☐ Pipe Lined

Invert Depth: **9.64** (ft.) Flow Characteristics: **Slow**

Infiltration: **None** Pipe Seal Cond: **Unknown**

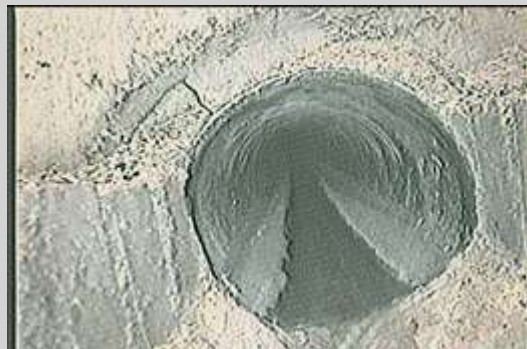
8 in. Circular Gravity Sewer

Pipe Material: **DIP/CI**

Invert Depth: **9.60** (ft.) Flow Characteristics: **Slow**

Pipe Seal Cond: **Cracked**
